# Manhole Inspection Summary

Manhole # S59U\_\_006MH

Insp Date: **4/30/08 3:07 PM**

**Location** Address: **1802 S. Newkirk St.**

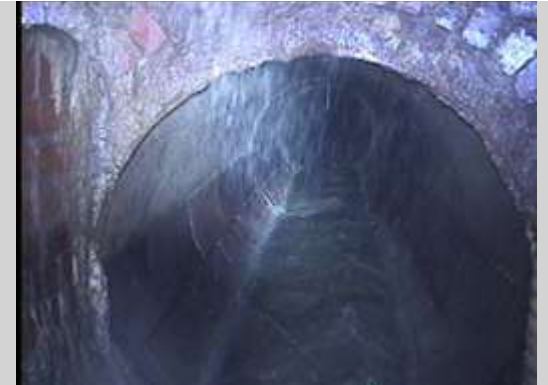
12 O'Clock Outflow

Pipe Height: **32.4** (in.) Rod and Bar (Angled)  
Pipe Material: **Clay** ☐ Pipe Lined  
Invert Depth: **24.75** (ft.) Flow Characteristics: **Fast**  
Deposits: ☒ None ☐ Mud ☐ Sludge ☐ Debris ☐ Grease  
Silt Depth: (in.) Deposits Extent:  
Infiltration: **None** Pipe Seal Cond: **Sound**

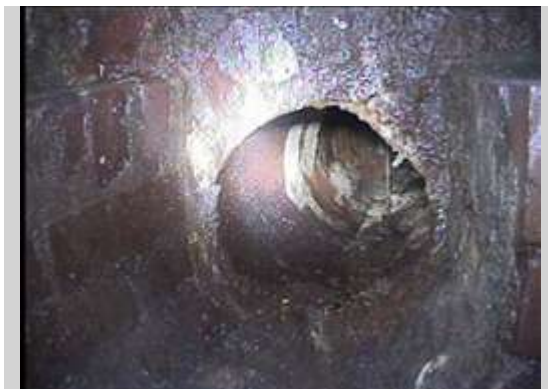
Pipe In @ 3 O'Clock

Pipe Height: **8.4** (in.) Rod and Bar (Angled)

Pipe Material: **Clay** ☐ Pipe Lined

Infiltration: **None**

Pipe Seal Cond: **Sound**

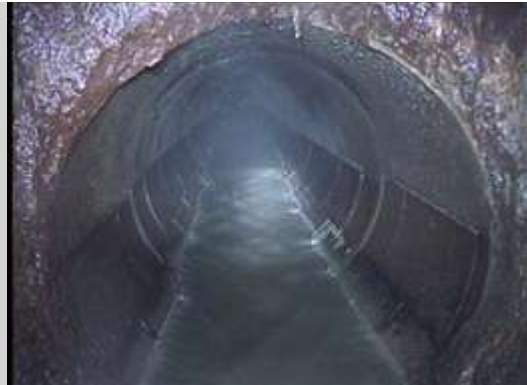
Pipe In @ 6 O'Clock

Pipe Height: **32.4** (in.) Rod and Bar (Angled)

Pipe Material: **Clay** ☐ Pipe Lined

Infiltration: **None** Pipe Seal Cond: **Sound**

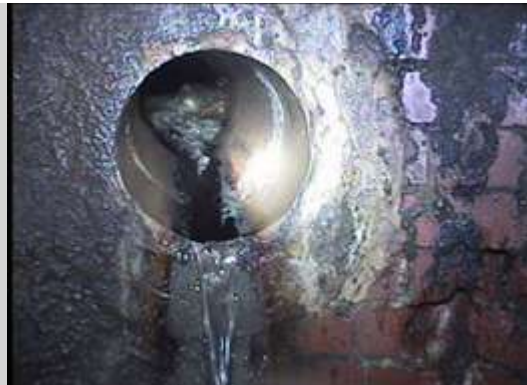
Pipe In @ 9 O'Clock

Pipe Height: **8.4** (in.) Rod and Bar (Angled)

Pipe Material: **Clay** ☐ Pipe Lined

Infiltration: **None** Pipe Seal Cond: **Sound**

Drop Condition: **Clogged**
